Re: Dam Safety Inspection Report, Little Falls Dam, Field File No. 55.01

Underwater Inspection

**Little Falls Dam
Willow River State Park
St. Croix County, Wisconsin**

Tainter Gate Inspection

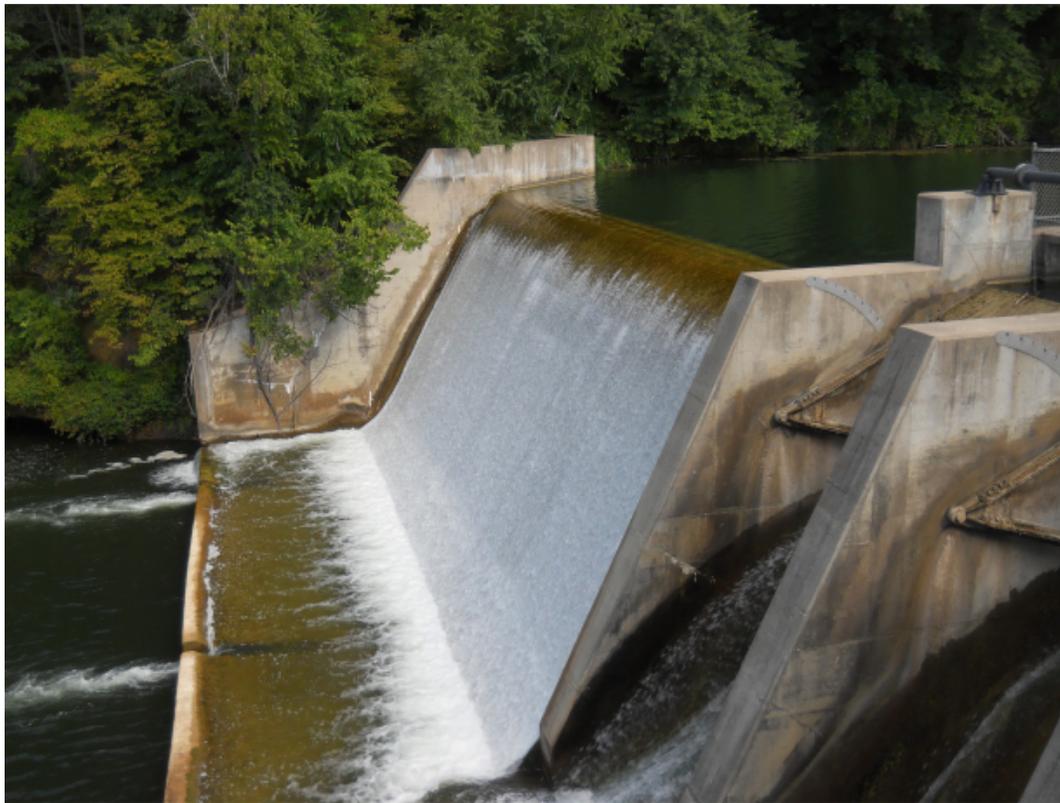
Photograph 2: Overflow Spillway

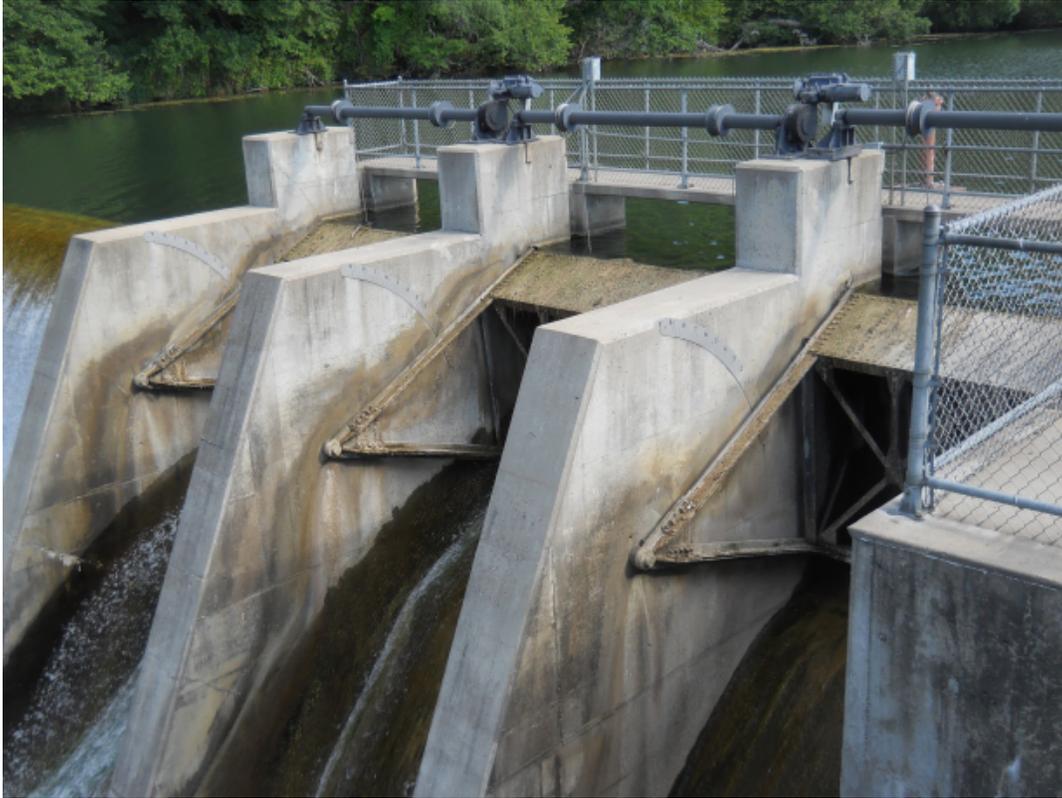
Photograph 3: Gates 2-4

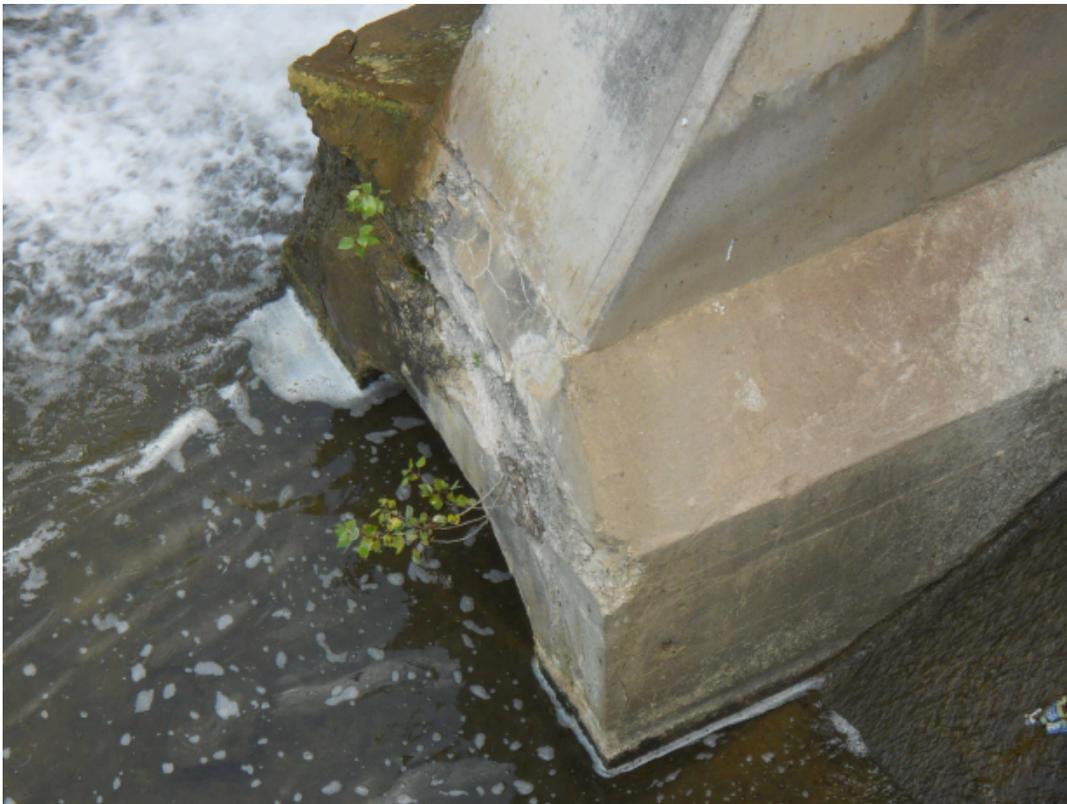
Photograph 6: Gates 2-4 – Sluice Gate Outlet

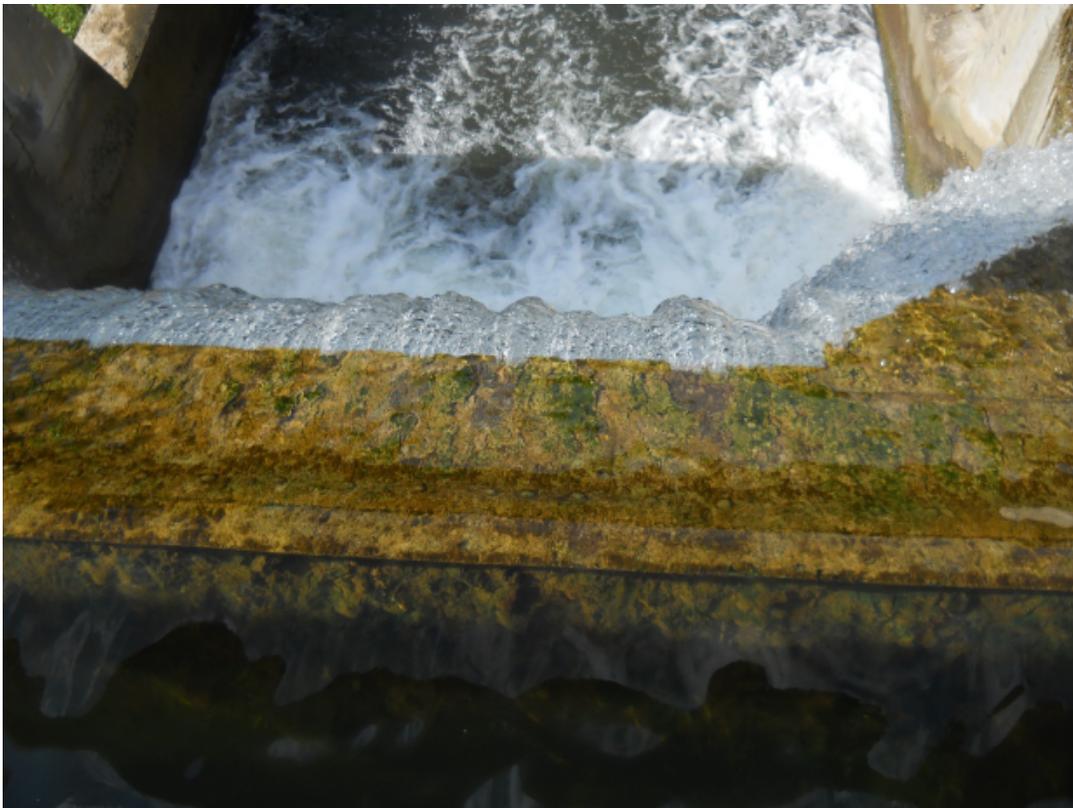
Photograph 8: Gate 1

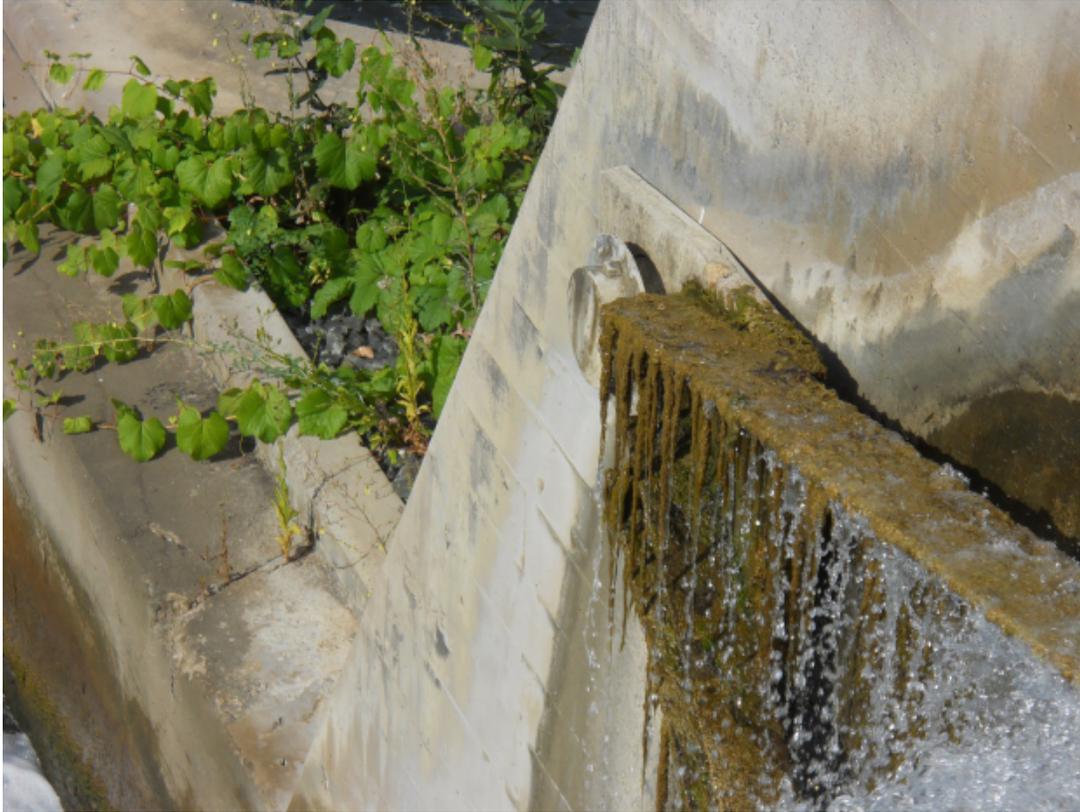
Photograph 9: Gate 1 – Right Trunnion

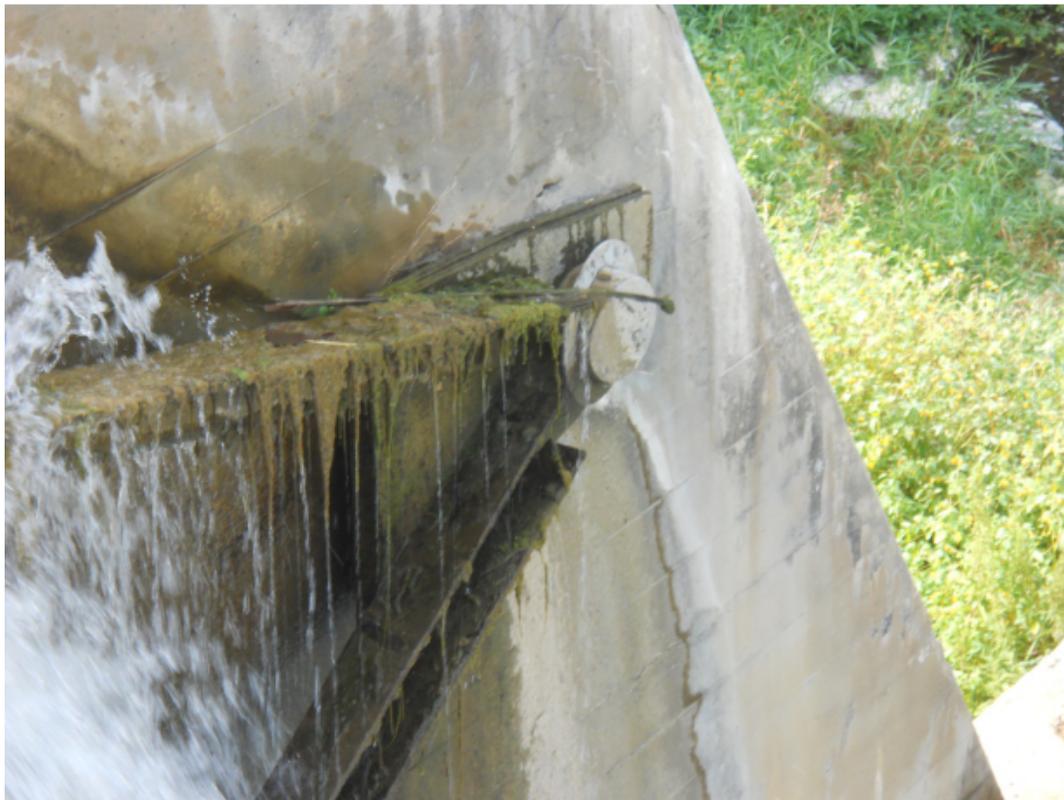
Photograph 10; Gate 1 – Left Trunnion

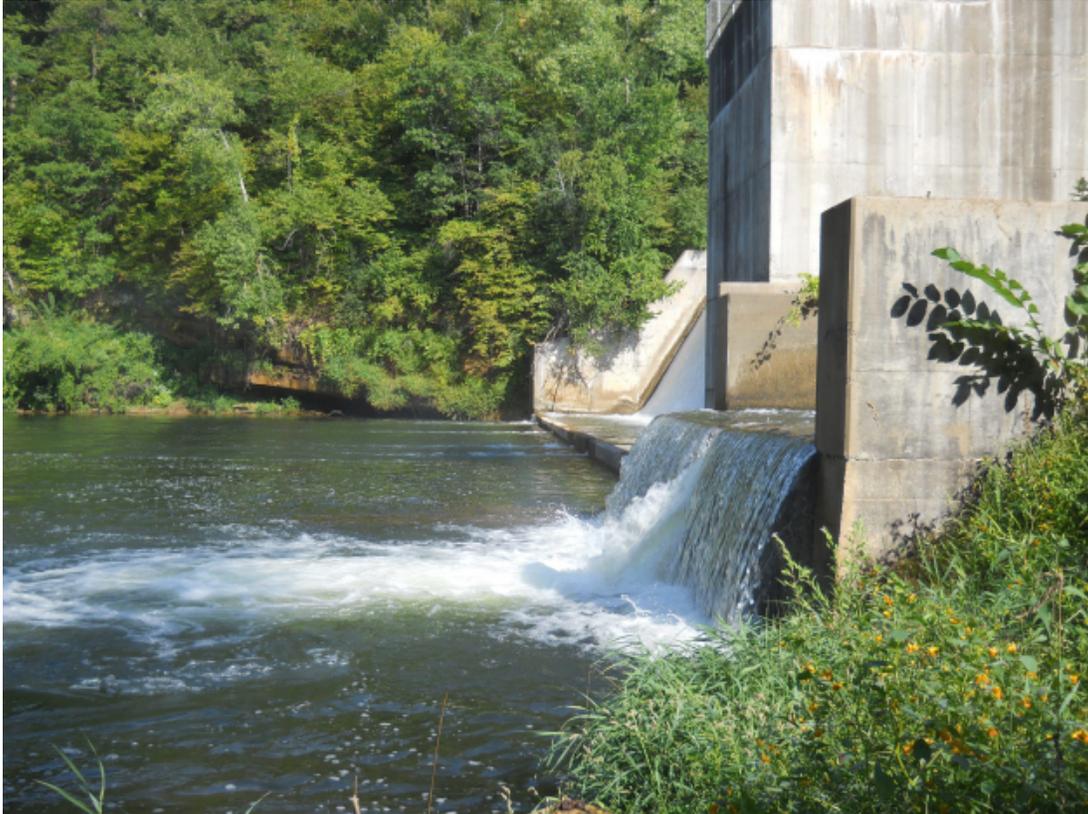
Photograph 11: Gate 1 – Downstream Side

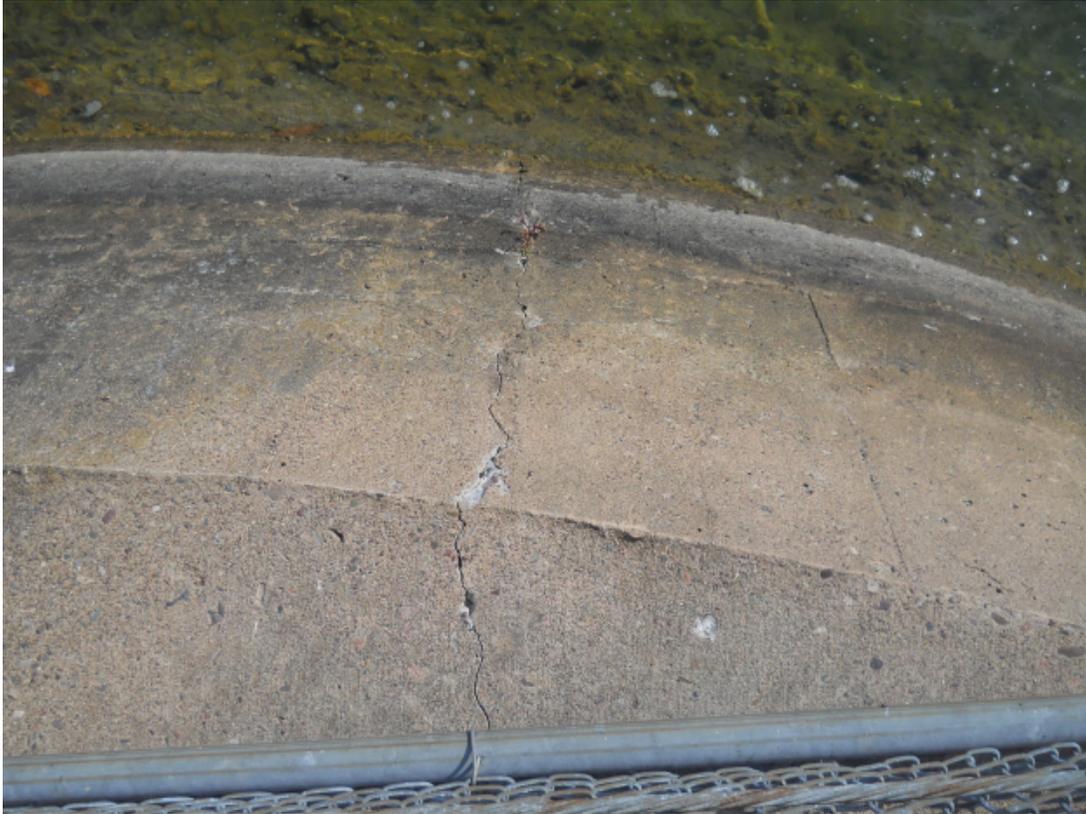
Photograph 13: Non-Overflow Section – Upstream Side

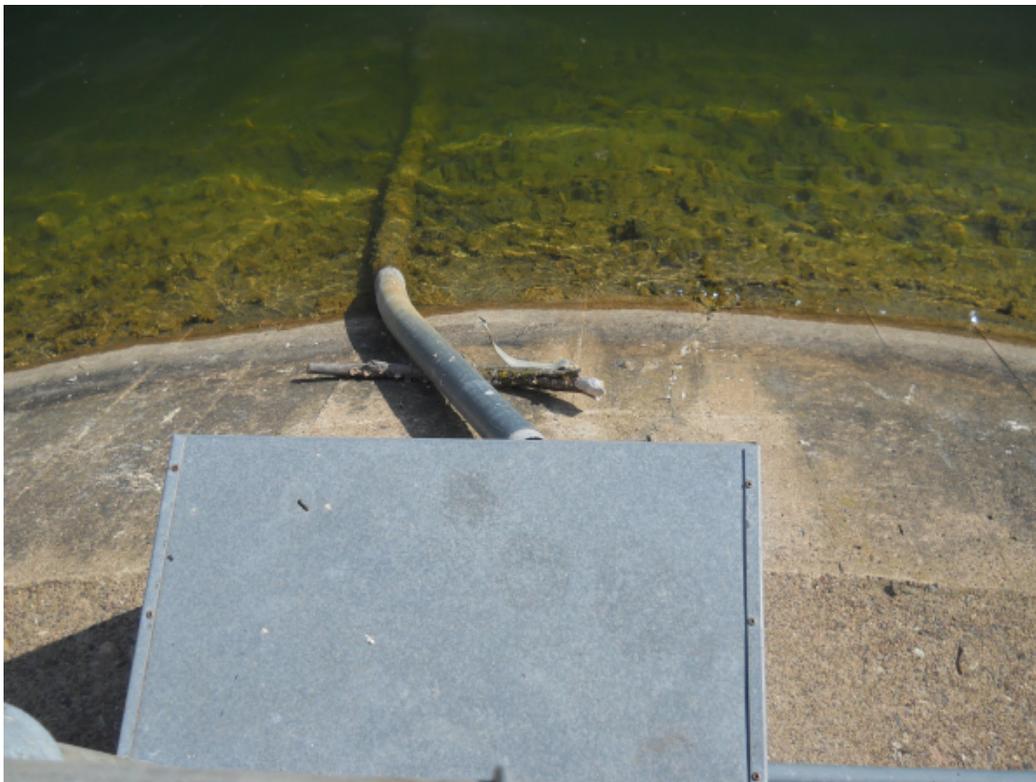
Photograph 14: Non-Overflow Section – Upstream Side

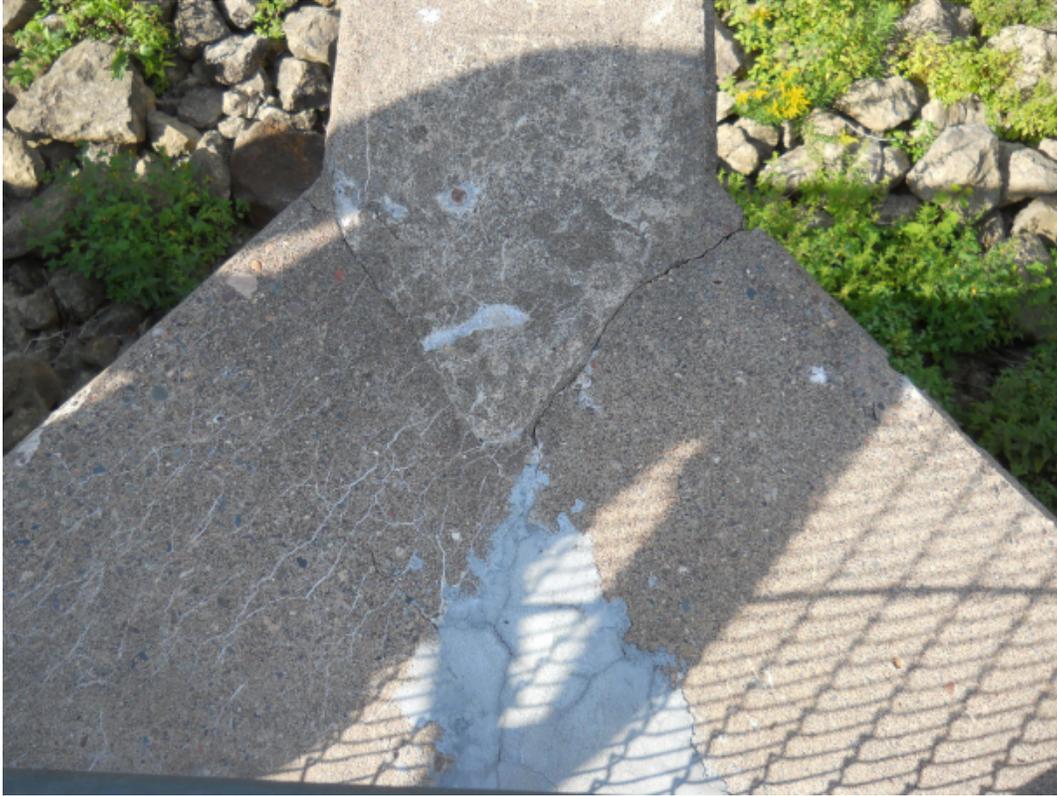
Photograph 15: Non-Overflow Section – Downstream Side

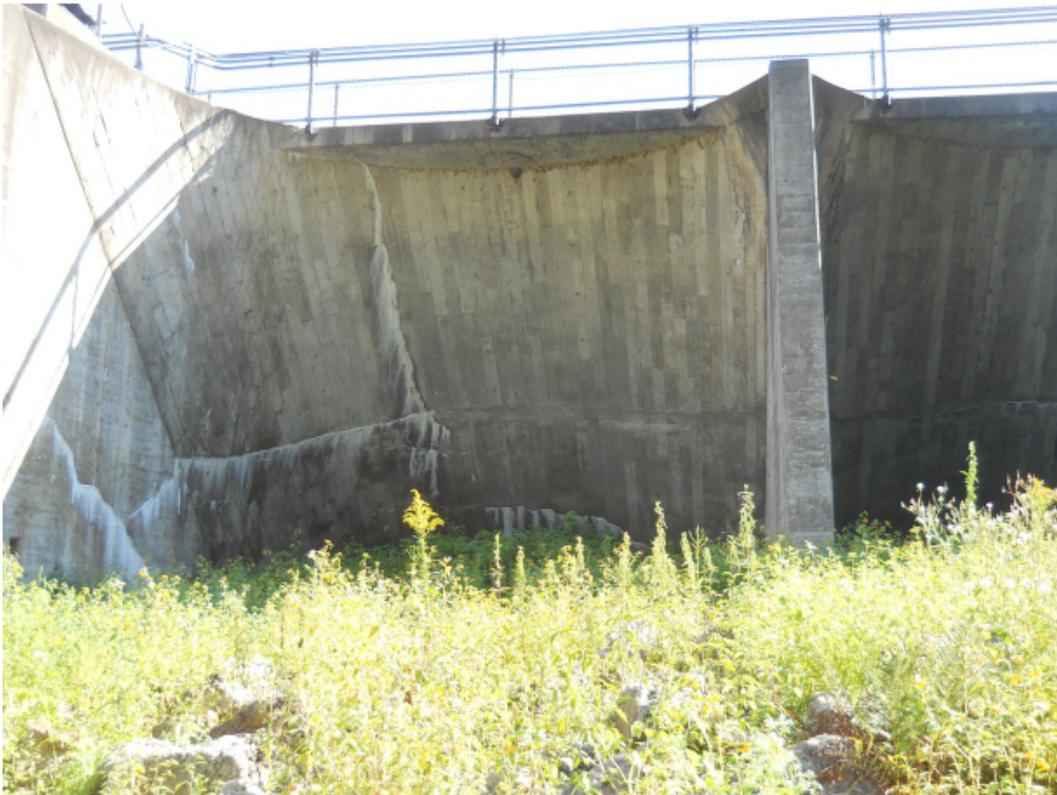
Photograph 16: Non-Overflow Section – Downstream Side

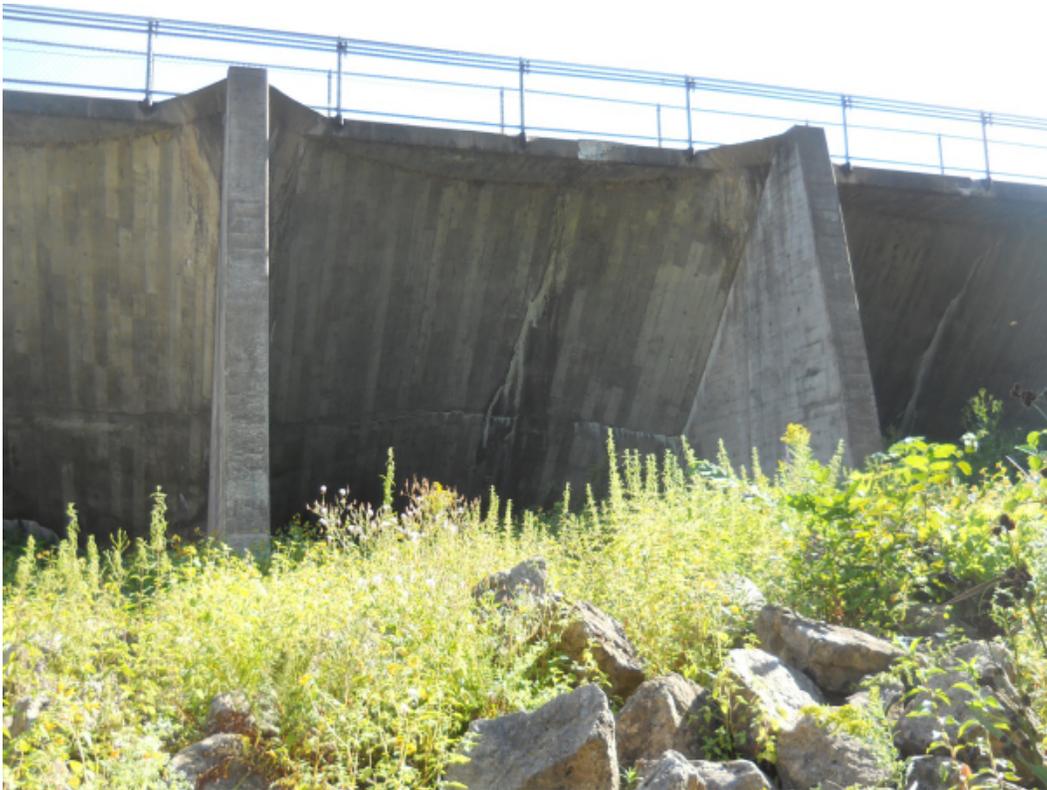
Photograph 17: Non-Overflow Section – Downstream Side

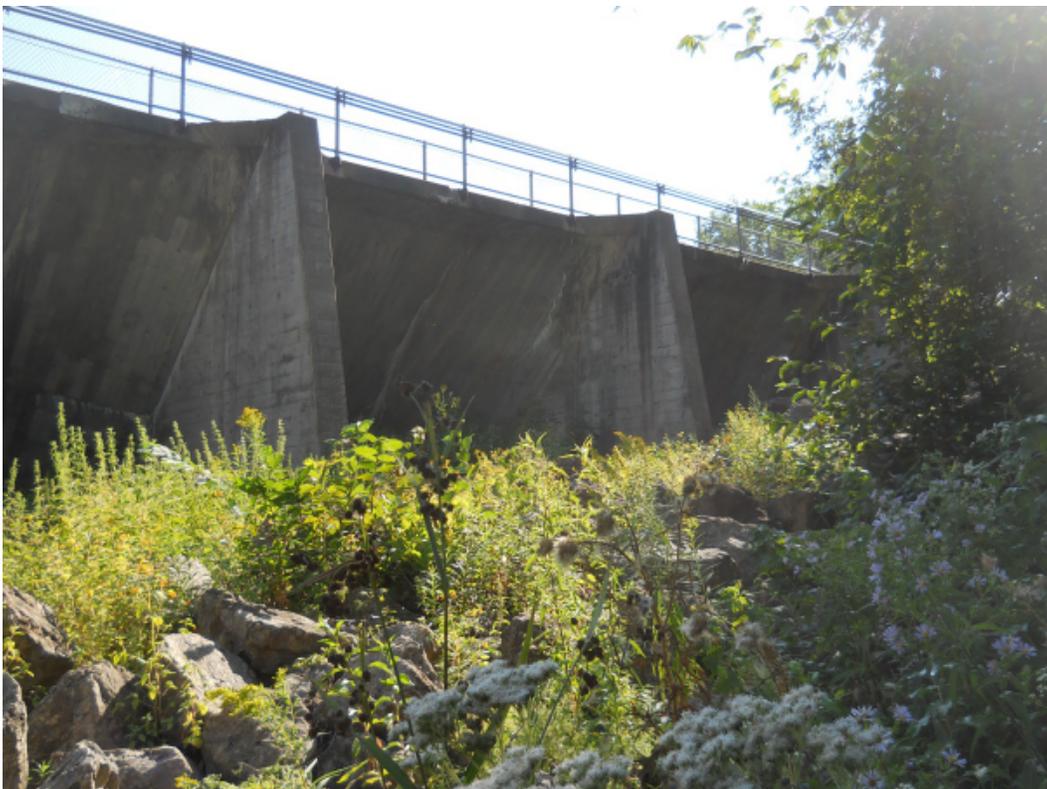
Photograph 18: Non-Overflow Section – Downstream Side

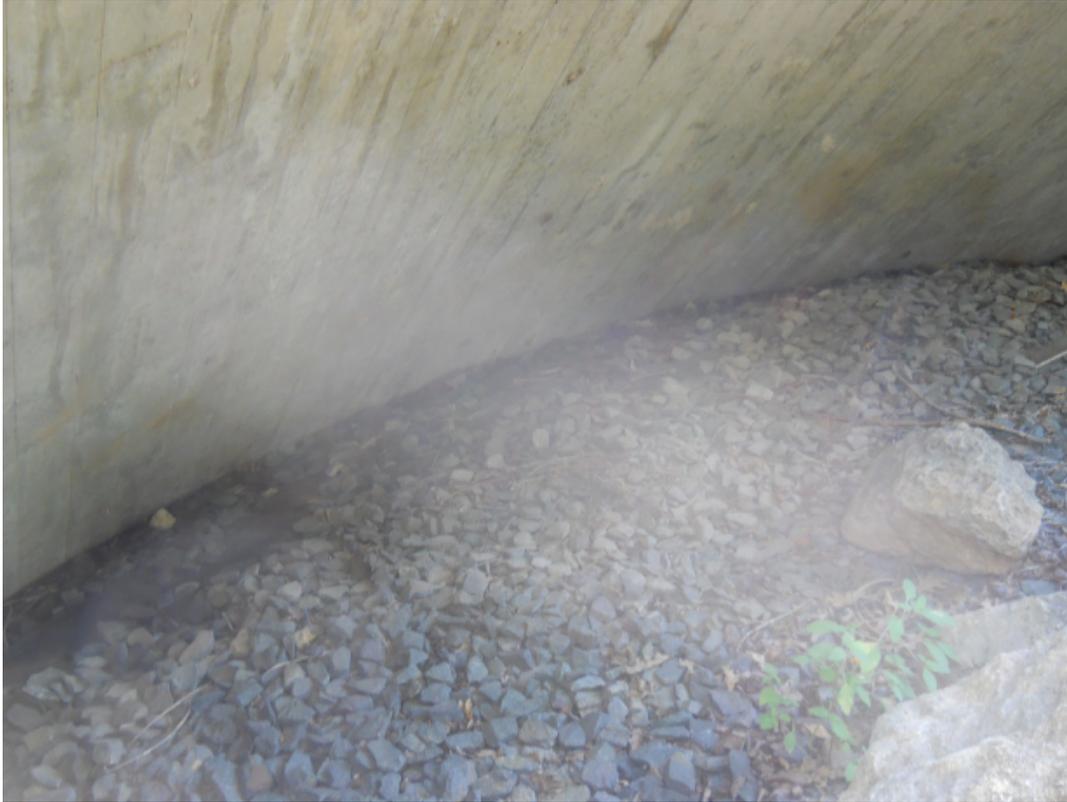
Photograph 19: Non-Overflow Section – Downstream Side

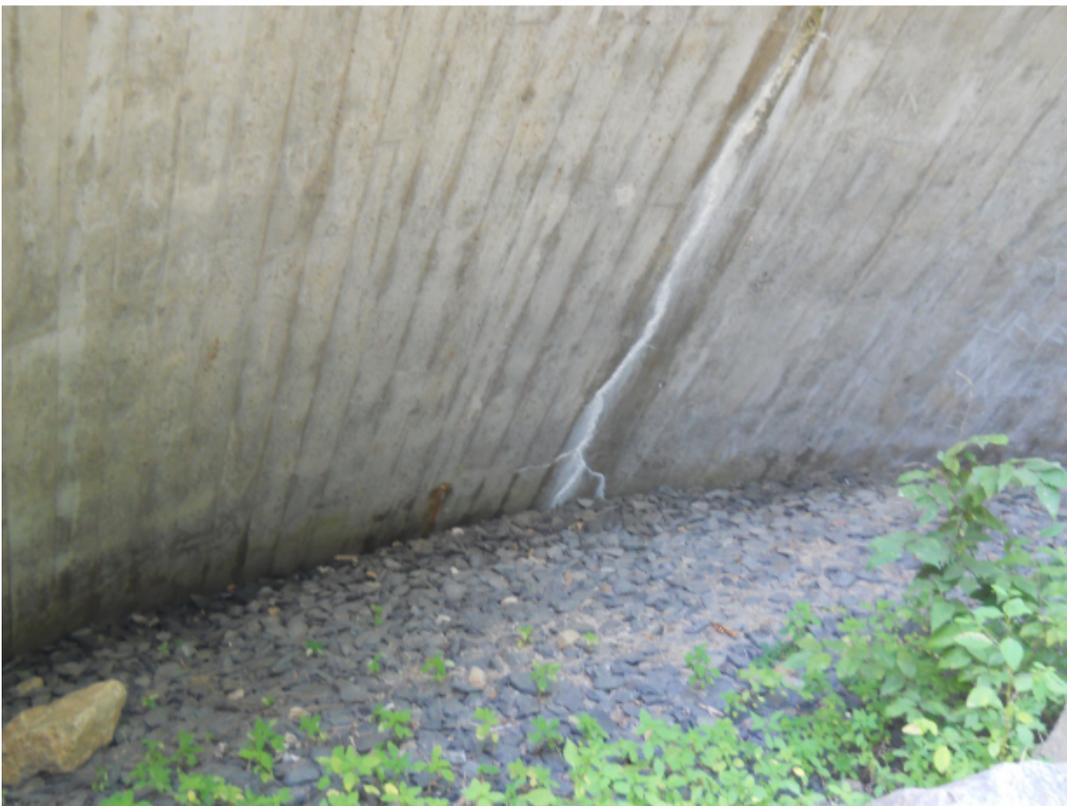
Photograph 20: Non-Overflow Section – Downstream Side

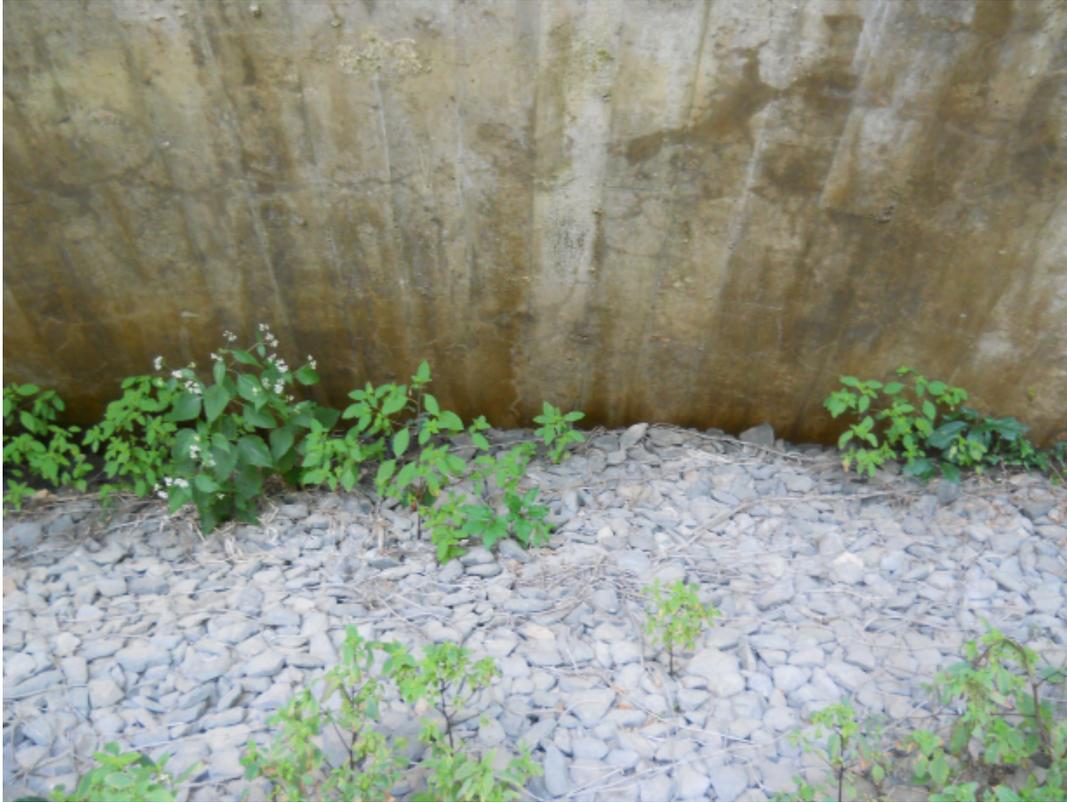
Photograph 21: Non-Overflow Section – Downstream Side

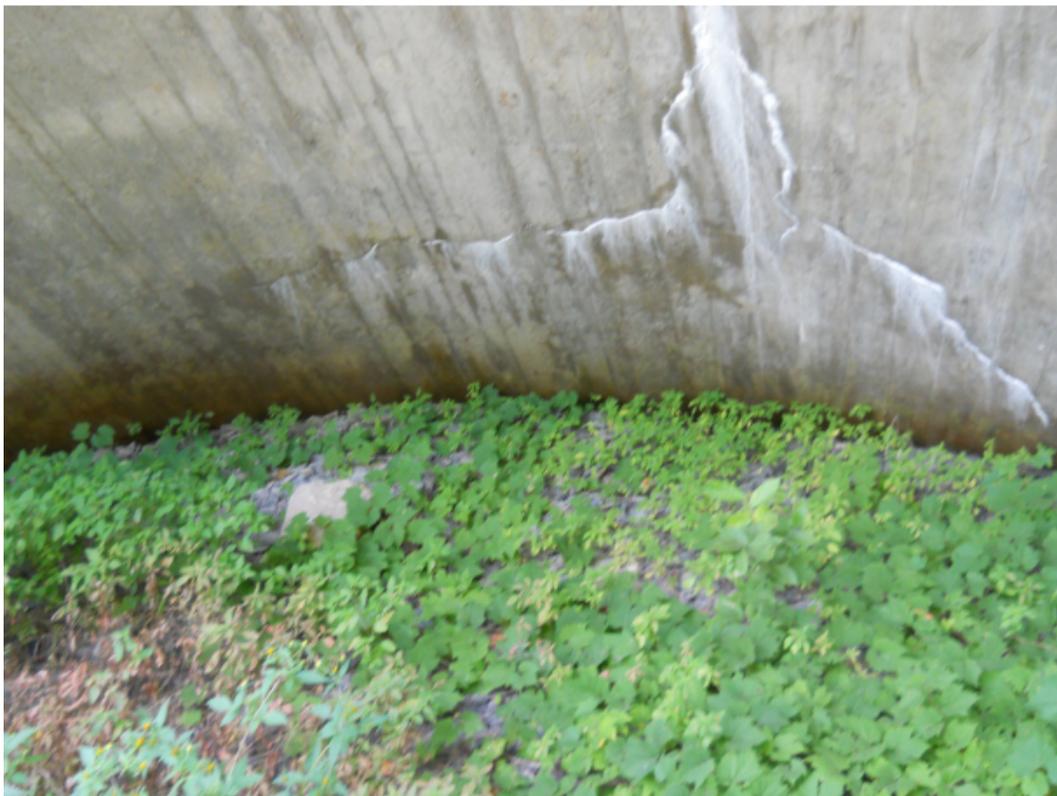
Photograph 22: Non-Overflow Section – Downstream Side

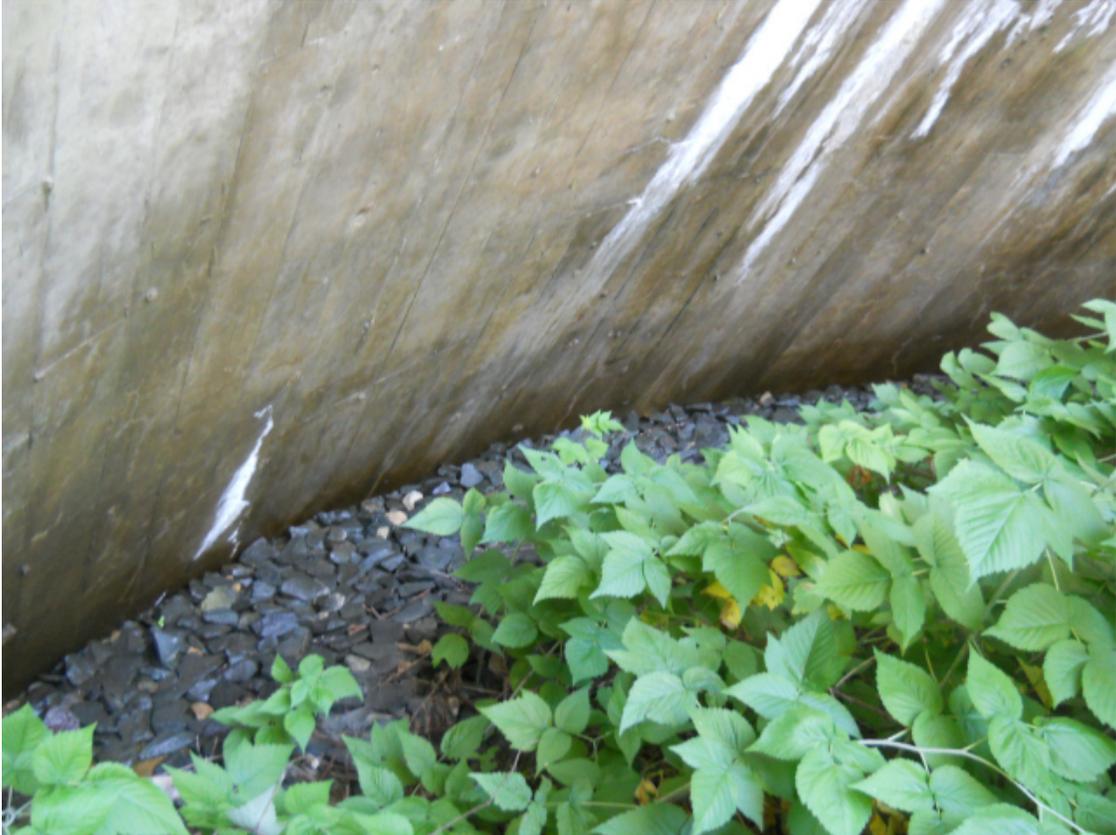
Photograph 23: Non-Overflow Section – Downstream Side
